SUMMARY
1234 Main St. Gulf Shores AL 36542
Buyer Name
06/14/2022 9:00AM

Lisa Memmolo
Internachi Certified Home Inspector,
Wind Mitigation,
Builright Home Inspections
251-233-0077
builrightsolutions@outlook.com

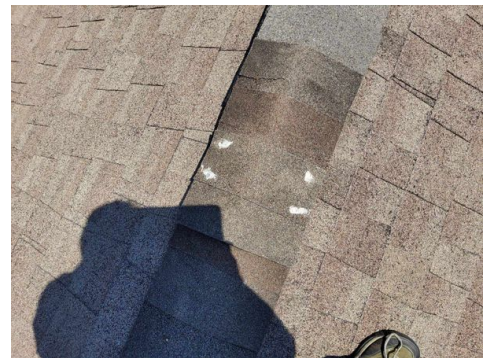
2.1.1 Coverings

EXPOSED NAILS

Roofing nails in the shingles, ridge cap shingles, and roof vents should be sealed with silicone sealant/ roofing cement. Exposed nails may lead to water intrusion which could damage the structure. Recommend a roofing contractor evaluate and repair.

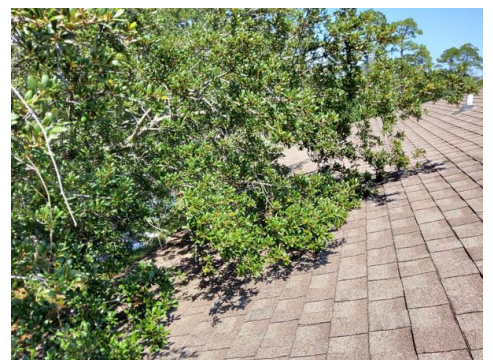
2.1.2 Coverings

TREE OVERHANG

Trees observed overhanging the roof. This can cause damage to the roof and prevent proper drainage. Recommend a qualified tree service cut back the trees.

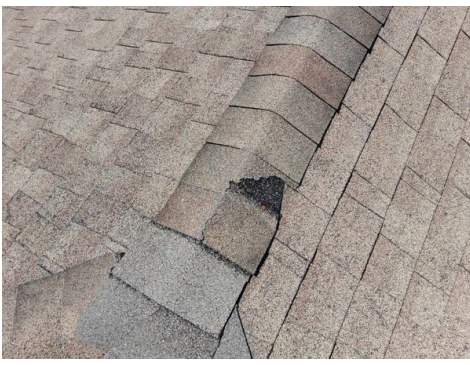
2.1.3 Coverings

DAMAGED (GENERAL)

Roof coverings showed moderate damage. Recommend a qualified roofing professional evaluate and repair.

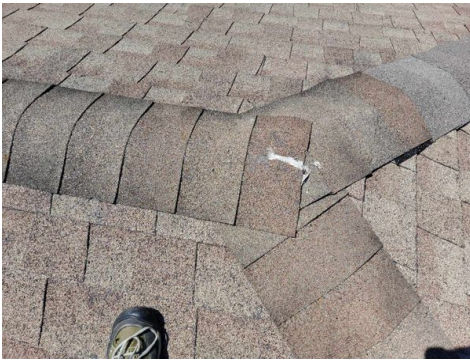
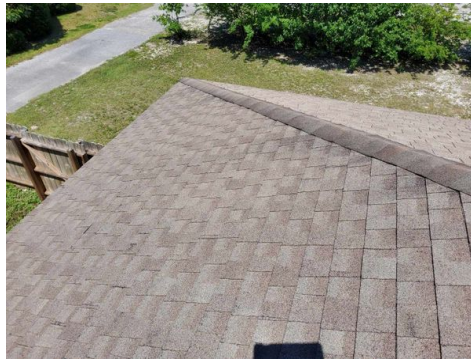
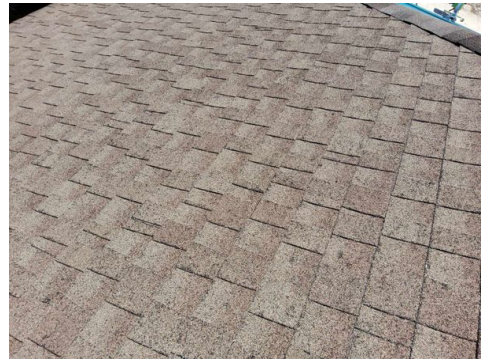
2.1.4 Coverings

HEAVY GRANULE LOSS

There is consistent heavy granule loss. This may be an indication that the roofing material is nearing the end of its functional lifespan. Further evaluation by roofing contractor

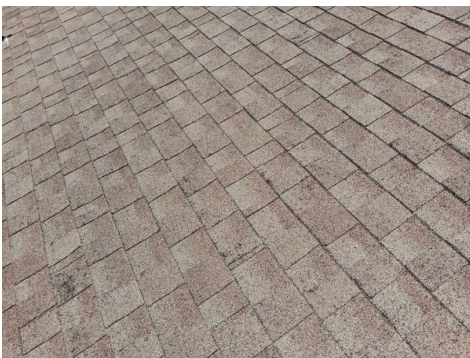
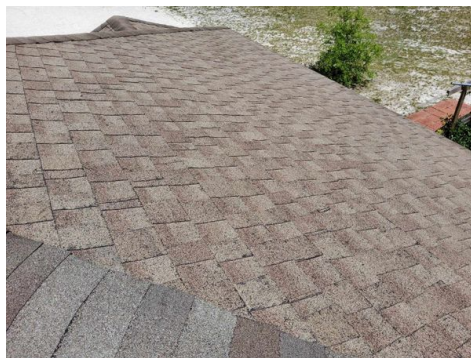
2.1.5 Coverings

MARGINAL DUE TO AGE

The roofing material is considered to be in marginal condition due to its age. The roofing material should be monitored for regular maintenance.

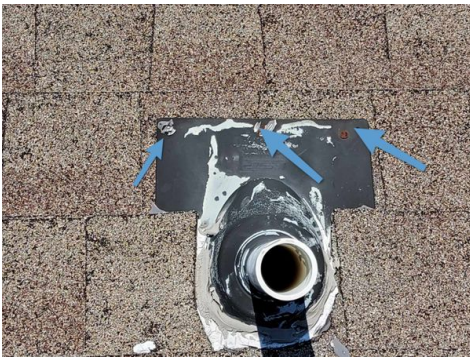
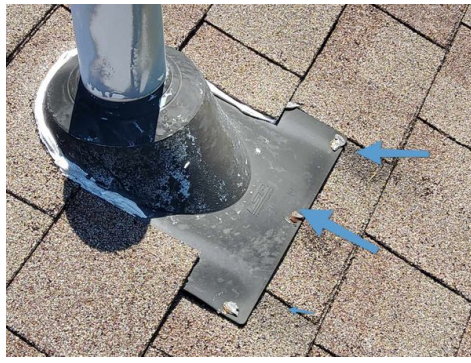
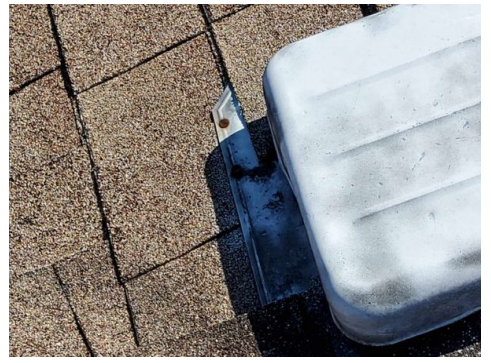
2.5.1 Plumbing Vents/Boots

EXPOSED NAILS IN THE PLUMBING VENT BOOT

The exposed nails in the plumbing vent boots should be sealed with roofing cement.

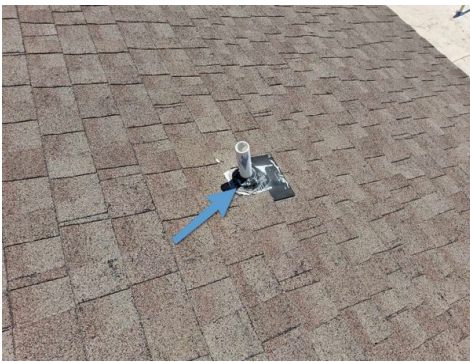
2.5.2 Plumbing Vents/Boots
IMPROPER REPAIR

The plumbing vent boot has been improperly repaired. The plumbing vent boot should be evaluated and repaired or replaced by a licensed roofing contractor.

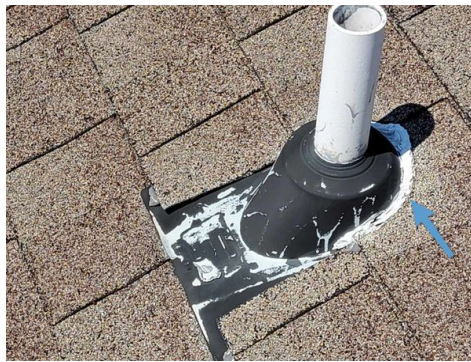
Inappropriate Caulk

Recommend that all windows and other areas of the exterior such as door thresholds, garage doors, etc where water can enter the home to be caulked and/or sealed. Caulking is a water resistant barrier secondary to the moisture vapor material (tyvek paper) used when homes are built.

Recommend to monitor caulking around windows, doors, and siding and have repairs/add caulking as necessary and as a part of annual home maintenance.

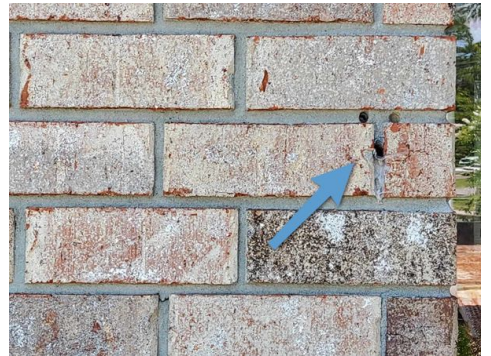
3.1.1 Siding, Flashing & Trim
OPEN PENETRATIONS

All open penetrations should be sealed against moisture intrusion and pests. Recommend repair,

Front Right

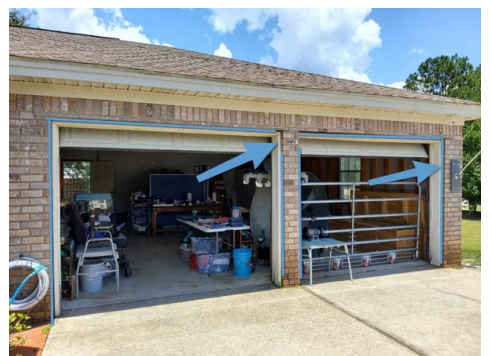
3.1.2 Siding, Flashing & Trim
CAULKING

Garage trim

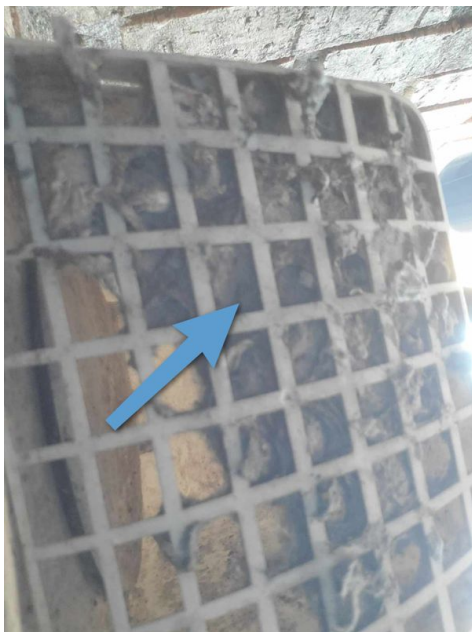
3.1.3 Siding, Flashing & Trim

DRYER VENT TERMINATION.

At the terminating end of the exhaust duct, the hood should be securely adhered to the structure. It should have a backdraft damper, the hood opening should point downward and should be at least 12 inches above the ground. No screen should be installed at the duct terminus. Caulk at the exterior wall penetration should be applied around the vent. Recommend repair.

Debris/ lint

Caulk at vent

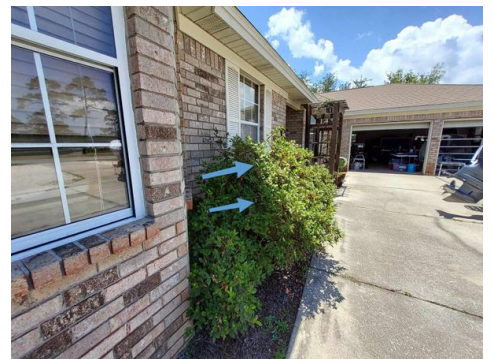
3.1.4 Siding, Flashing & Trim

CUT BACK TREES/SHRUBS

Trees/shrubbery should be cut back away from the siding to prevent damage.

Cut back shrub from house

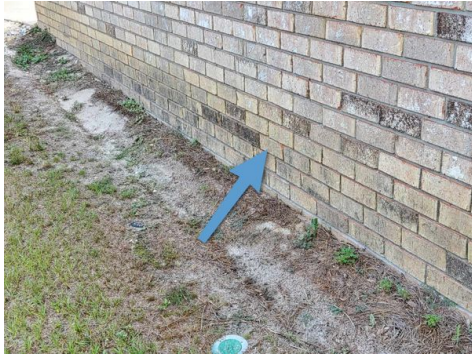
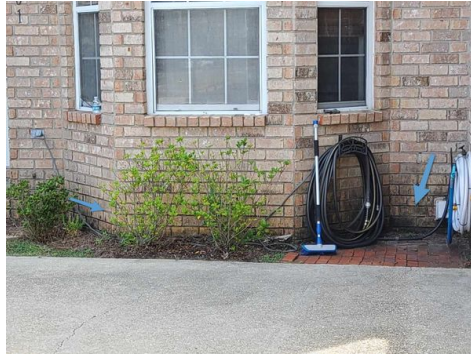
3.1.5 Siding, Flashing & Trim

MILDEW/ALGAE

There are signs of algae and/or mildew on the siding. This is a cosmetic issue and is not uncommon especially on shaded portions of the home. Recommend that said areas be washed or cleaned on a regular basis.

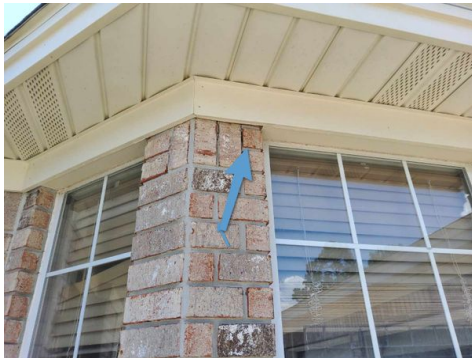
3.1.6 Siding, Flashing & Trim

MISSING MORTAR

Missing mortar at exterior walls in multiple locations. Further deterioration can lead to moisture intrusion therefore damage to the structure. Recommend further monitoring and repair.

Front Right

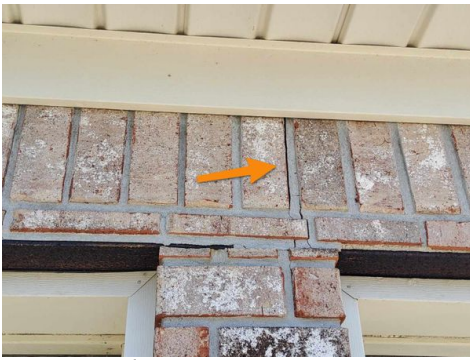
3.1.7 Siding, Flashing & Trim

CRACKING - MINOR

Siding showed cracking in one or more places. This is a result of temperature changes and settling, and is typical as homes with brick age. Recommend monitoring for further movement.

Garage at driveway

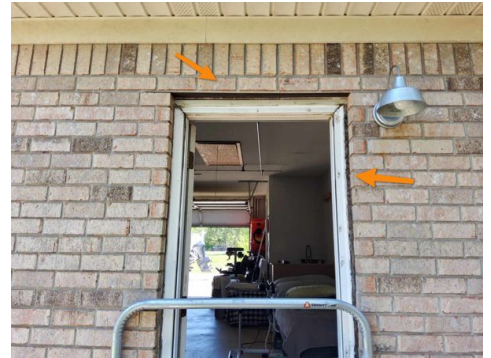
3.2.1 Exterior Doors

CAULKING

Caulk was *missing / deteriorated / substandard* in some areas. For example, *around windows / around doors / at siding butt joints / at siding-trim junctions / at wall penetrations*. Recommend that a qualified person renew or install caulk as necessary. Where gaps are wider than 1/4 inch, an appropriate material other than caulk should be used. Caulking should be evaluated and applied as part of annual home maintenance

Garage door needs recalling. Growth present

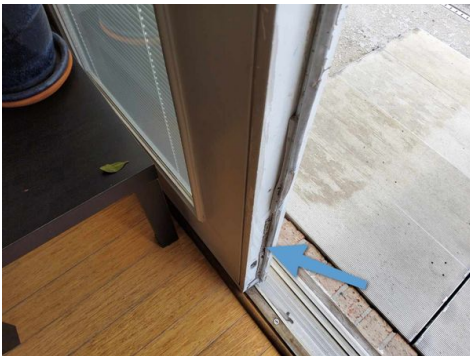
3.2.2 Exterior Doors

DAMAGED/ INSUFFICIENT WEATHERSTRIPPING

Damaged or insufficient weatherstripping on exterior door. The goal of weather stripping is to prevent rain, moisture and pests from getting in, while also keeping interior air in, which can save energy on heating and air conditioning. Recommend repair.

Patio doors

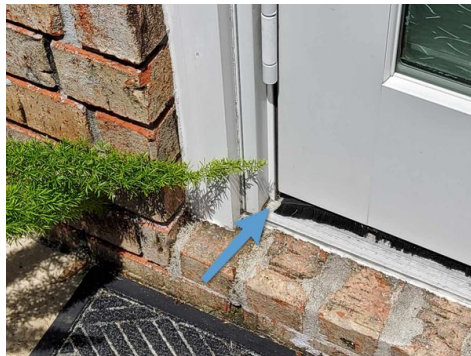
Rear bath exterior door

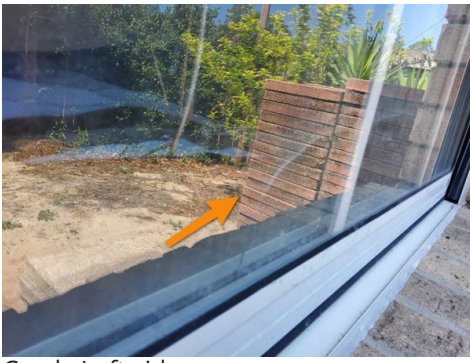
3.3.1 Windows

DAMAGED

One or more windows appears to have general damage, but are operational. Recommend a window professional or general contractor repair as necessary.

Crack. Left side

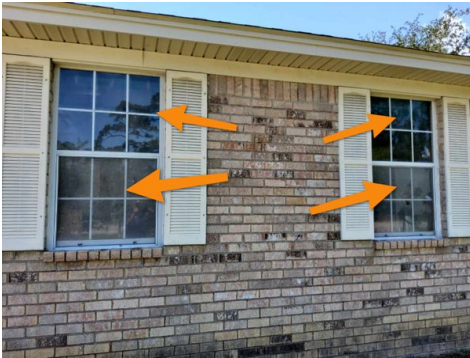
3.3.2 Windows
FAILED SEAL

Observed condensation between the window panes, which indicates a failed seal. Failed seals reduces the energy efficiency of the windows. Recommend qualified window contractor evaluate & replace.

At garage

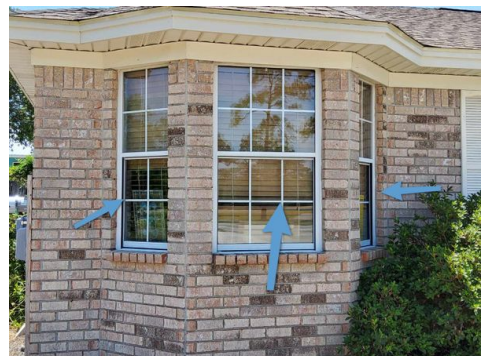
3.3.3 Windows
MISSING SCREEN

Window missing screen. Recommend replacement.

Front left

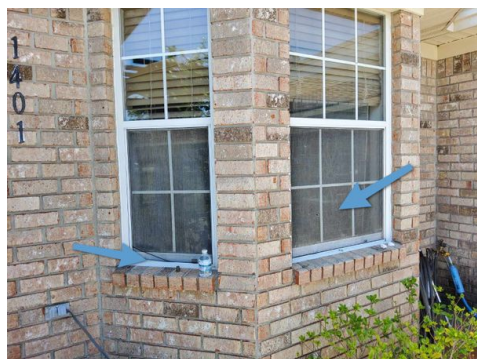
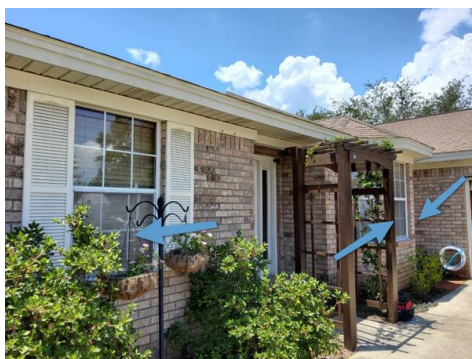
DAMAGED SCREEN.

Damaged screen. Recommend repair.

Front Right

3 screens damaged at front

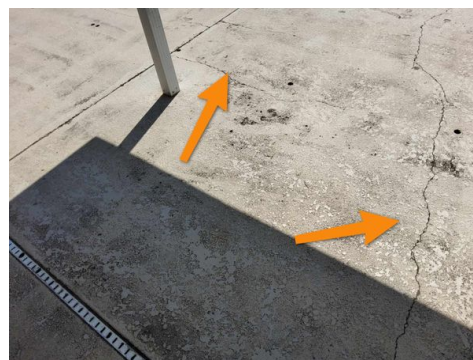
PATIO CRACKING - MINOR

Normal settling & cracking observed. Recommend monitor and/or patch/seal.

Back patio

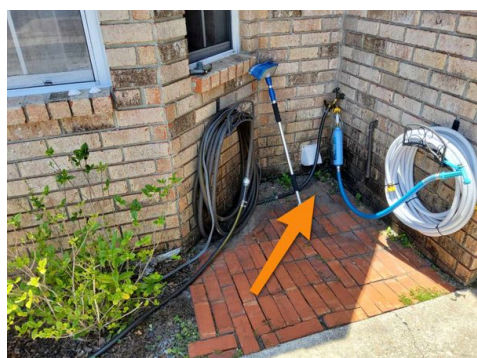
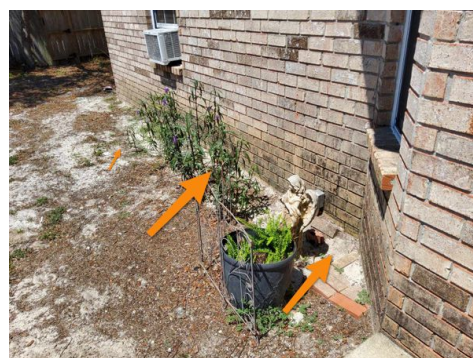
NEGATIVE GRADING

Grading is sloping towards the home in some areas. This could lead to water intrusion and foundation issues. Recommend qualified landscaper or foundation contractor regrade so water flows away from home. Installing gutters to drain water away from house is recommended.

Front Right

Back left

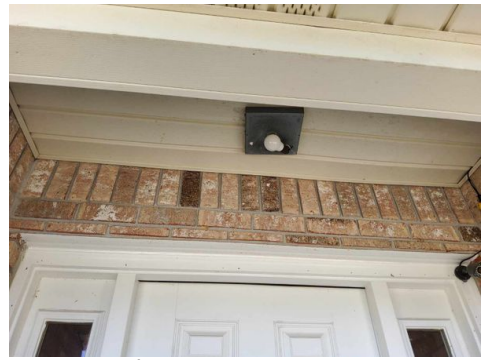
LIGHT FIXTURE COVER MISSING

The light fixture cover is missing and should be repaired. Exposed bulbs are a safety hazard

Front porch

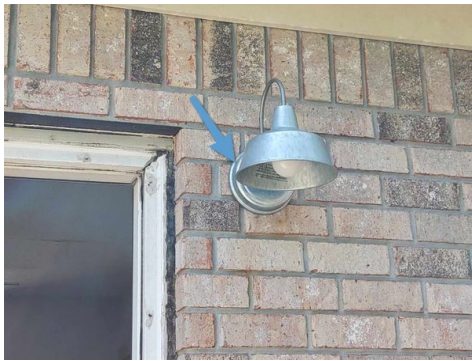
3.6.2 Exterior Fixtures and Receptacles **CAULK MISSING AT EXTERIOR FIXTURE**

Recommend caulk

Back Porch garage

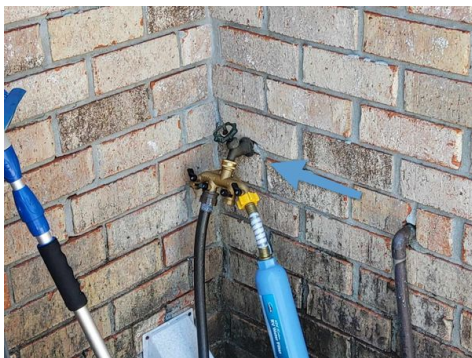
3.7.1 Plumbing **ANTI-SIPHON DEVICE**

Faucets not equipped with an anti-siphon device. Anti-siphon devices normalize the pressure in pipes to prevent possible backflow and cross contamination. Recommend installing anti siphon device.

Front Right

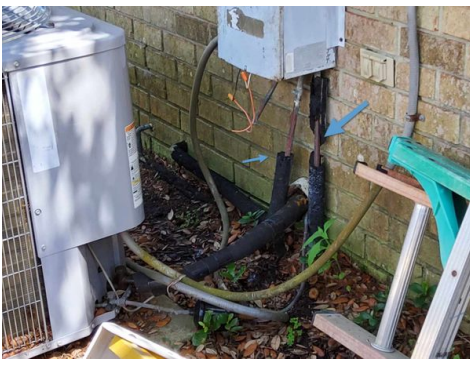
3.7.2 Plumbing **A/C LINES/ INSULATION**

It is recommended that all A/C lines be insulated. Recommend repair,

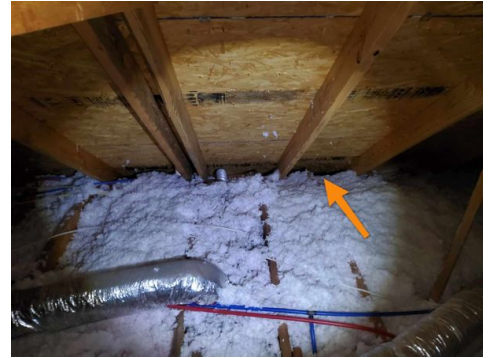
4.2.1 Ventilation

BAFFLES NEEDED AT SOFFIT

Attic baffles or are an essential part of keeping your home well ventilated, reducing the moisture in the house, and increasing energy efficiency. Insulation baffles are attached to the top of your attic ceiling below the roof; they serve as shoots to move air through your attic from soffit vents. When Insulation is packed into rafter bays it blocks air flow. Adding baffles will increase air flow therefore cooling attic which in turn increases energy efficiency. Recommend installing baffles.

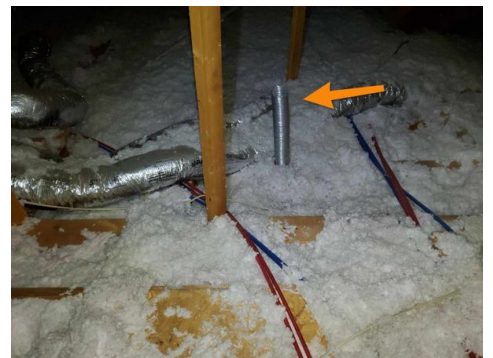
4.4.1 Exhaust Systems

BATHROOM VENTS INTO ATTIC

Bathroom fan vents into the attic, which can cause moisture and microbacterial growth in attic space. Recommend install exhaust fan to terminate to the exterior.

Venting moisture into attic

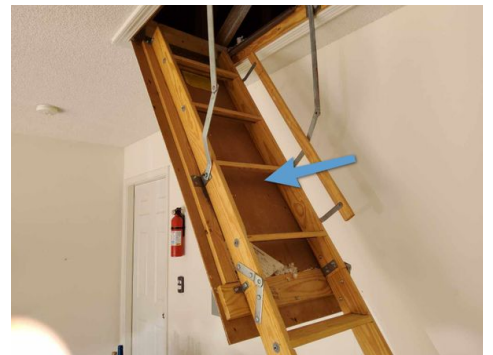
4.6.1 Pull down stairs/ Attic access

PULLDOWN STAIRS INSULATION

The pull down stairs should be insulated to increase energy efficiency. Recommend repair.

Missing insulation

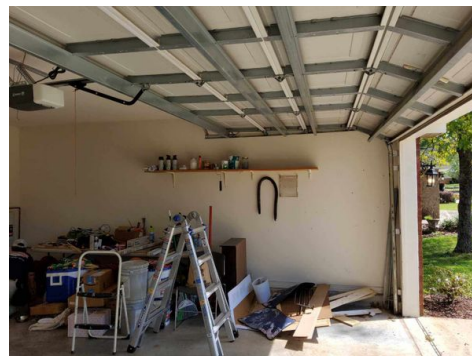
6.3.1 Walls & Firewalls

UNABLE TO CONFIRM 1 HR. FIRE BARRIER

The inspector is unable to confirm the presence of a one-hour fire rated ceiling / wall covering.

To slow the spread of fire from the garage to the living space, widely accepted modern safety standards required a 1-hour fire separation barrier between the garage and all adjoining living spaces. This includes the use of type-X drywall and limitations on penetrations. Although it may not have been required when the home was originally constructed, and homes are not required to be updated to comply with newly enacted building standards, for life-safety reasons the Inspector recommends that you update home construction to comply with modern fire separation standards.

Finished space limits confirmation of firewall

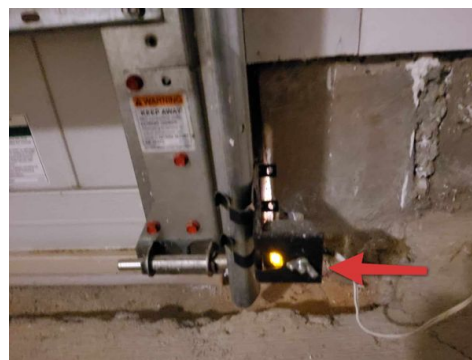
I checked to see if photo-electric eyes are installed. The vertical distance between the photo-eye beam and the floor should be no more than 6 inches.

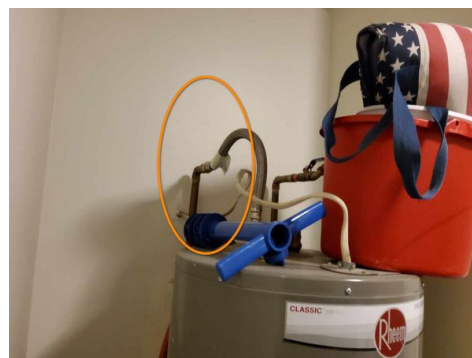
7.1.1 Water Heater **NO EXPANSION TANK 2012**

No expansion tank was present. Expansion tanks allow for the thermal expansion of water in the pipes. These have been required in certain areas for new installs or replacement since 2012. Recommend a licensed plumber evaluate.

Expansion tank

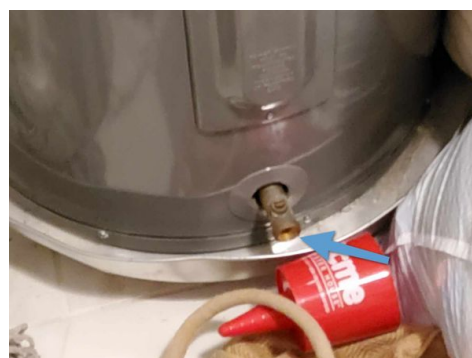
7.1.2 Water Heater **DRAIN NOT DRAINING INTO PAN**

The drain outlet is not draining into the Pan. If the water heater were to have a leak the drain would drain water onto the sub floor not into the pan which could cause major damage to the occupants' belongings and to the structure. Recommend repair.

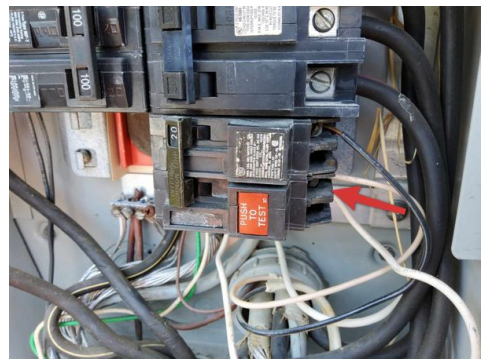
8.2.1 Main Panel **BREAKER INCORRECTLY WIRED**

Circuit breaker was incorrectly wired / installed. This indicates that work was probably not performed by a licensed electrician and poses a safety hazard. Recommend that a licensed electrician check the entire panel and repair and replace as need.

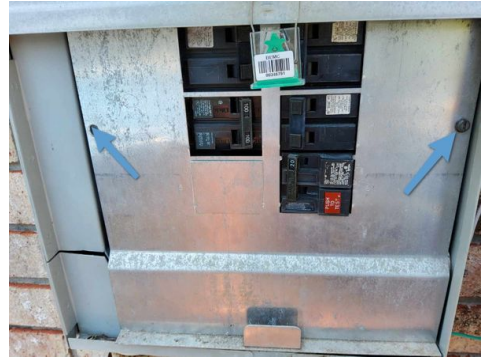
8.2.2 Main Panel

MISSING SCREWS IN PANEL COVER

Panel cover should contain all screws with no open holes. Screws should be an approved panel screw with a blunt tip and fine threads. Recommend repair.

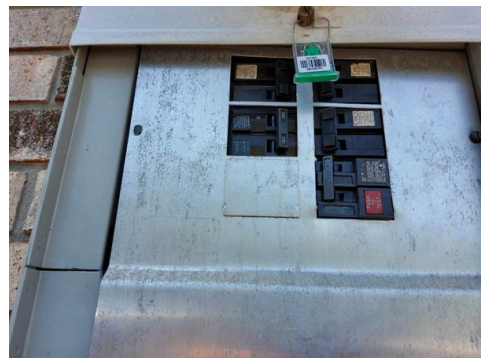
8.2.3 Main Panel

MISSING LABELS ON PANEL

At the time of inspection, panel was missing labeling. Recommend a person identify and map out locations.

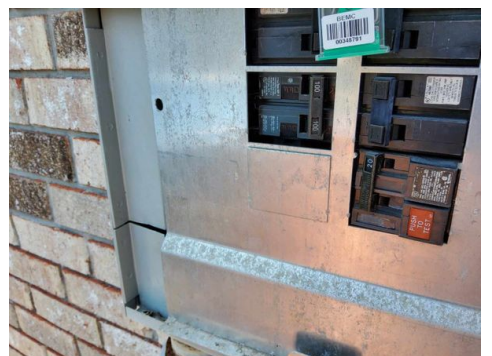
8.2.4 Main Panel

IMPROPER PANEL COVER

Panel cover does not match incorrect fit. Recommend repair

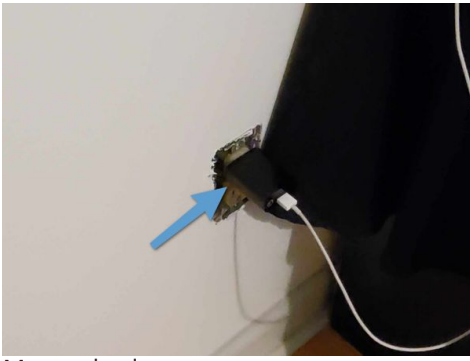
8.5.1 Fixtures, Switches & Receptacles

COVER PLATES MISSING

One or more receptacles are missing a cover plate. This may cause a short and is shock risk. Recommend installation of plates.

Master bedroom

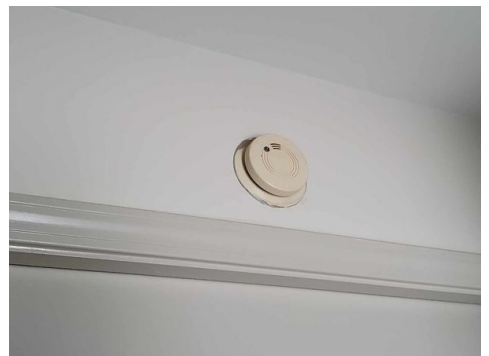
8.7.1 Smoke Detectors

SMOKE DETECTORS HAVE AGED BEYOND THEIR RECOMMENDED LIFESPAN

Smoke detectors have aged. Recommend replacement

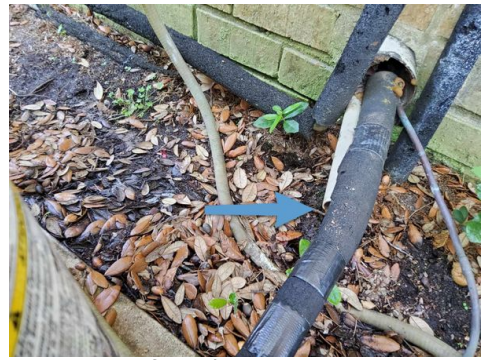
9.1.1 Air Handler

AIR HANDLER CONDENSATE LINE LOCATION

Air handler condensate line drains at foundation. Recommend draining away from the house.

Drain away from house

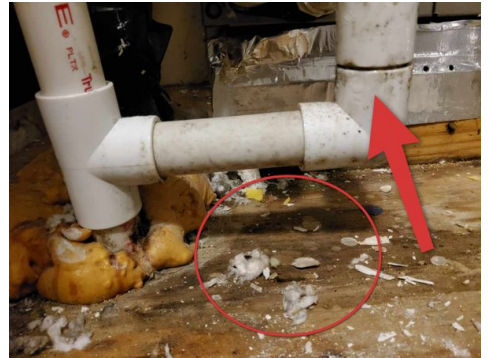
9.1.2 Air Handler

LEAK AT CONDENSATION LINE IN CLOSET

At the time of the inspection the inspector observed active water leak at the condensation line.. Recommend immediate repair. Moisture can lead to microbacterial growth causing health and indoor air quality issues and may lead to structural damage

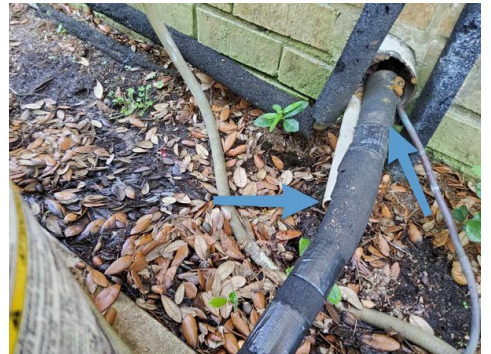
9.2.1 Cooling Equipment

DAMAGED OR MISSING INSULATION IN THE A/C REFRIGERANT LINES

Proper installation of insulation is recommended. Insulation helps protect A/C lines from condensation.

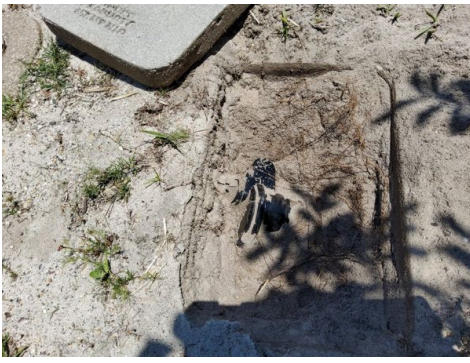
10.1.1 Main Water Shut-off Device

BURIED

Water meter is buried unable to locate.. Recommend calling the city or a plumber to repair.

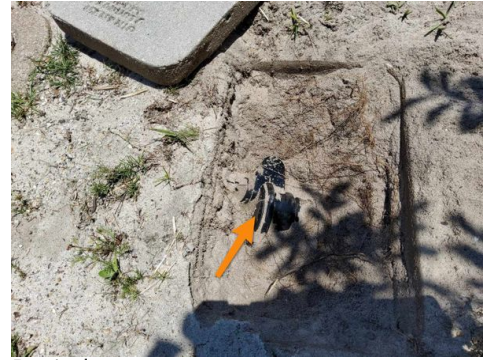
10.1.2 Main Water Shut-off Device
NO DIGITAL DISPLAY READOUT

The inspector is unable to read the water meter. The digital display did not turn on. Recommend contacting the water company to diagnose and remedy.

Buried

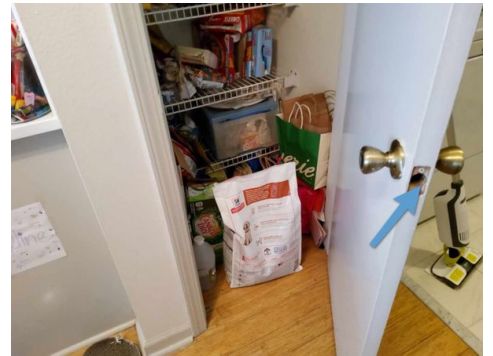
11.1.1 Doors
DOOR DOESN'T LATCH

Door doesn't latch properly. Recommend handyman repair latch and/or strike plate.

Pantry door hardware loose

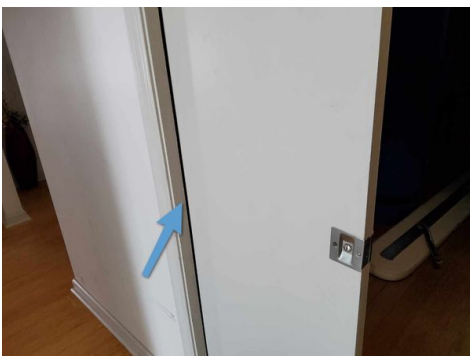
11.1.2 Doors
DOOR STICKS

Door sticks and is tough to open. Recommend sanding down offending sides.
[Here is a helpful DIY article](#) on how to fix a sticking door.

Storage room

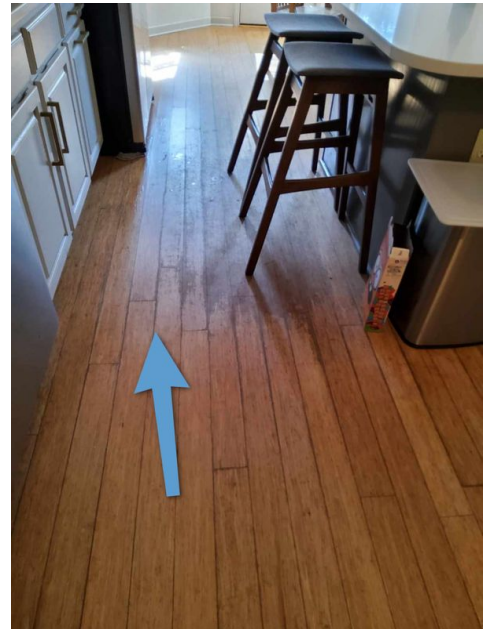
11.3.1 Floors

MODERATE WEAR

Floors in the home exhibited moderate surface wear along major paths of travel. Recommend a qualified flooring contractor evaluate for possible re-finish.

Kitchen

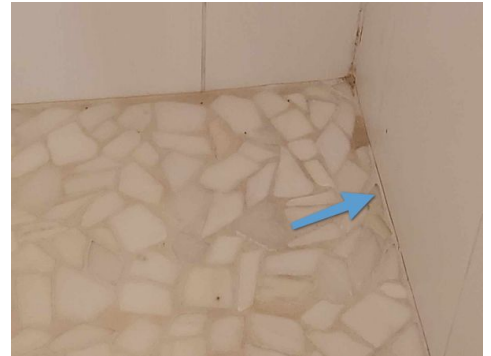
12.1.1 Bathtub/ Shower

CAULK AT FLOOR

Caulk is missing or deteriorated along the base of one or more bathtub/ shower. It should be replaced where deteriorated and/or applied where missing to prevent water intrusion and damage to the floor structure.

Master shower

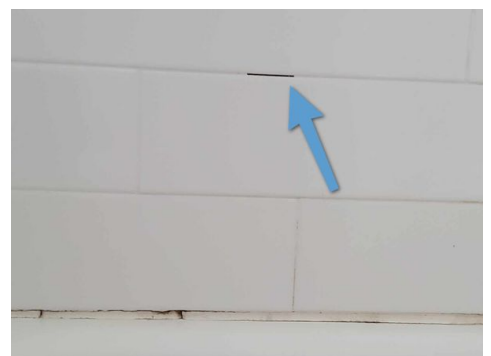
12.1.2 Bathtub/ Shower

GROUT DETERIORATED

Grout at the tiles around the bathtub is damaged or deteriorated. This can allow water to intruded behind the tiles cause loose tiles and microbial growth issues behind tiles. For example, deteriorated or missing grout, cracked, missing or loose tiles, etc. Recommend repair tile and/or grout as necessary.

Hall bath

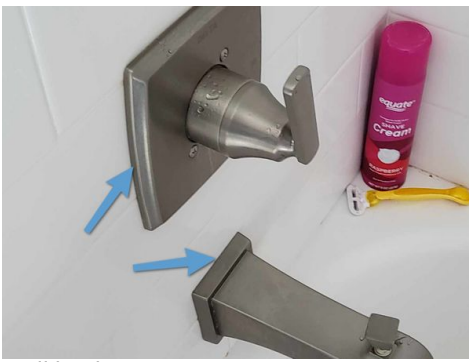
12.1.3 Bathtub/ Shower

CAULK AT SPOUT

Caulk is missing or deteriorated around the base of the bathtub spout. It should be replaced where deteriorated and/or applied where missing to prevent water intrusion and damage to wall structures.

Hall bath

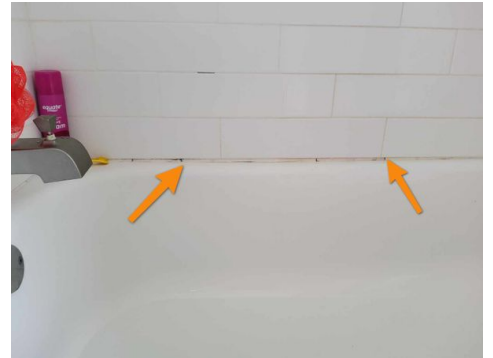
12.1.4 Bathtub/ Shower

CAULKING AT SURROUND

Caulk is missing or deteriorated above one or more bathtubs, where the tub surround meets the tub. It should be replaced where deteriorated and/or applied where missing to prevent water intrusion and damage to the wall structure.

Hall bath

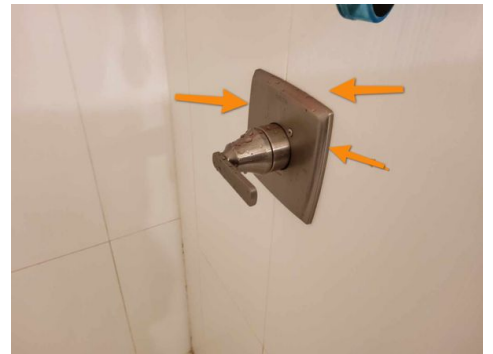
12.1.5 Bathtub/ Shower

CAULKING AT CONTROLS BACKPLATE

Caulk is missing or deteriorated around the base of water control backplate. It should be replaced where deteriorated and/or applied where missing to prevent water intrusion and damage to wall structures.

Master shower

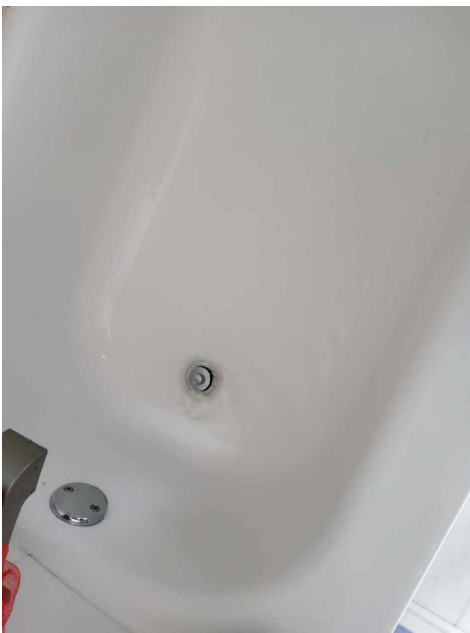
12.1.6 Bathtub/ Shower

CLOGGED OR DRAINS SLOWLY

One or more bathtub drains are clogged or drain slowly. Drain(s) should be cleared as necessary, and by a qualified plumber if necessary.

Hall bath

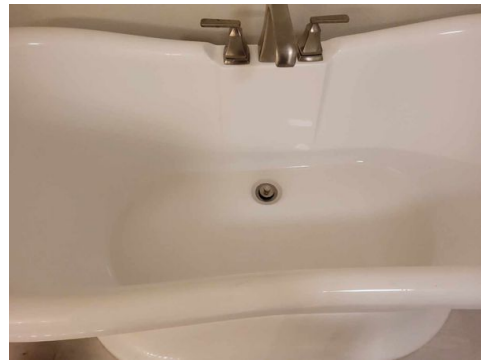
12.1.7 Bathtub/ Shower

WATER NOT DRAINING EFFICIENTLY

The shower is not draining efficiently(i.e. standing water, slow draining to drain). Standing water in the shower can cause mildew and residue to build-up, leaving tiles slick. Also, grout can deteriorate from standing water. Recommend cleaning drains and monitoring for necessary repair by plumbing contractor

Tub in master

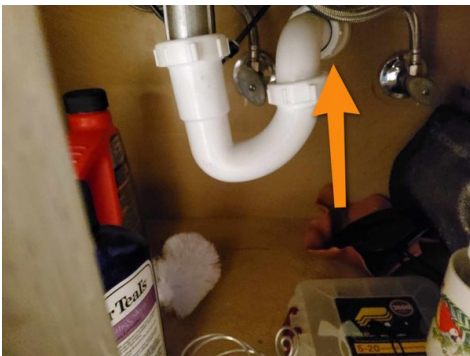
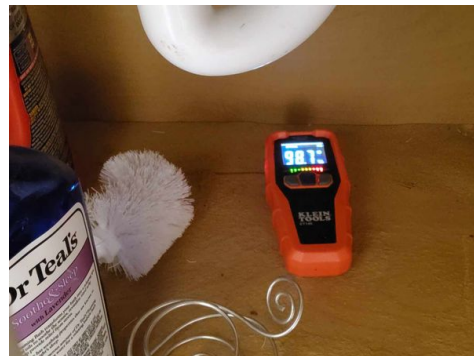
12.6.1 Sink/countertop

SINK DRAIN LEAK

One or more sink drains have an active leak. For example, at pipe fittings and/or junctions between pipe and sink. A qualified plumber should evaluate and repair as necessary.

Leak left sink master bath

Active moisture left sink master bath

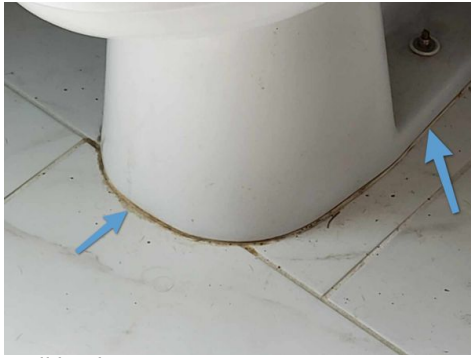
12.7.1 Toilets

NO OR BAD CAULK BASE

Caulk around the base of the toilet was missing, substandard and/or deteriorated. Modern standards require caulk to be installed around the entire toilet base where it meets the floor for sanitary reasons. Without it, soiled water can soak into flooring and sub-floor materials if the toilet overflows. Condensation from the toilet can also soak into the flooring. Recommend caulk around toilet bases per standard building practices.

Hall bath

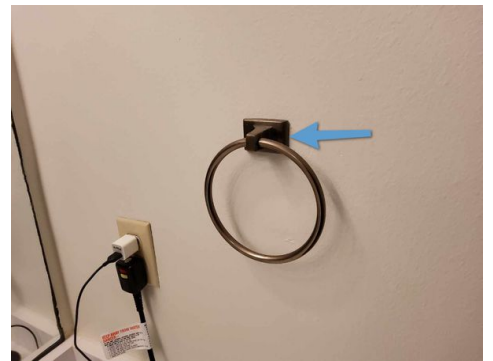
12.8.1 Ceiling/ Walls

TOWEL BAR NOT SECURED

Talibar is not secured to the wall. Recommend repair

Right side Master bath

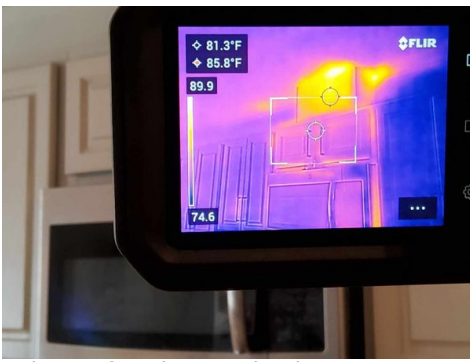
15.3.1 Exhaust Fan

EXHAUST FAN CHASE IMPROPERLY INSULATED

Inspector observed through thermal imaging heat loss in cabinet containing chase for oven exhaust. Recommend insulating exhaust fan duct to reduce home energy loss.

Exhaust fan chase at kitchen

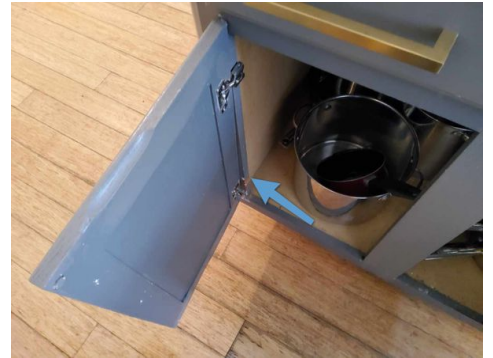
15.4.1 Countertops & Cabinets

CABINET HINGE LOOSE

One or more cabinet hinges were loose. Recommend a qualified handyman or cabinet contractor repair.

Island

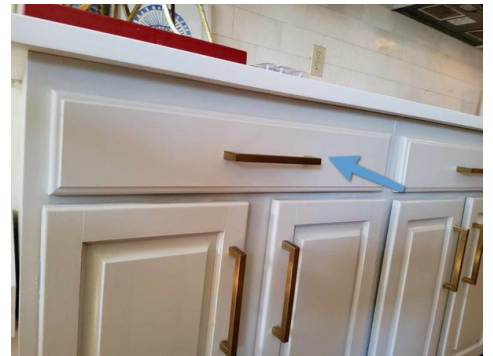
15.4.2 Countertops & Cabinets

DRAWER DOESNT OPEN

Drawer to left of stove doesn't open fully. Recommend repair
